1.0 PURPOSE AND NEED

Telegraph Street starts at the I-15 Interchange at milepost (MP) 10 (Green Springs Drive Interchange) and extends to State Route 9, the main route from I-15 to Hurricane, Utah. It is the primary east-west route through Washington City. The section of Telegraph Street that extends from Green Springs Drive to 300 East is also known as State Route 212 (SR 212).

Figure 1.1 Study Area Map

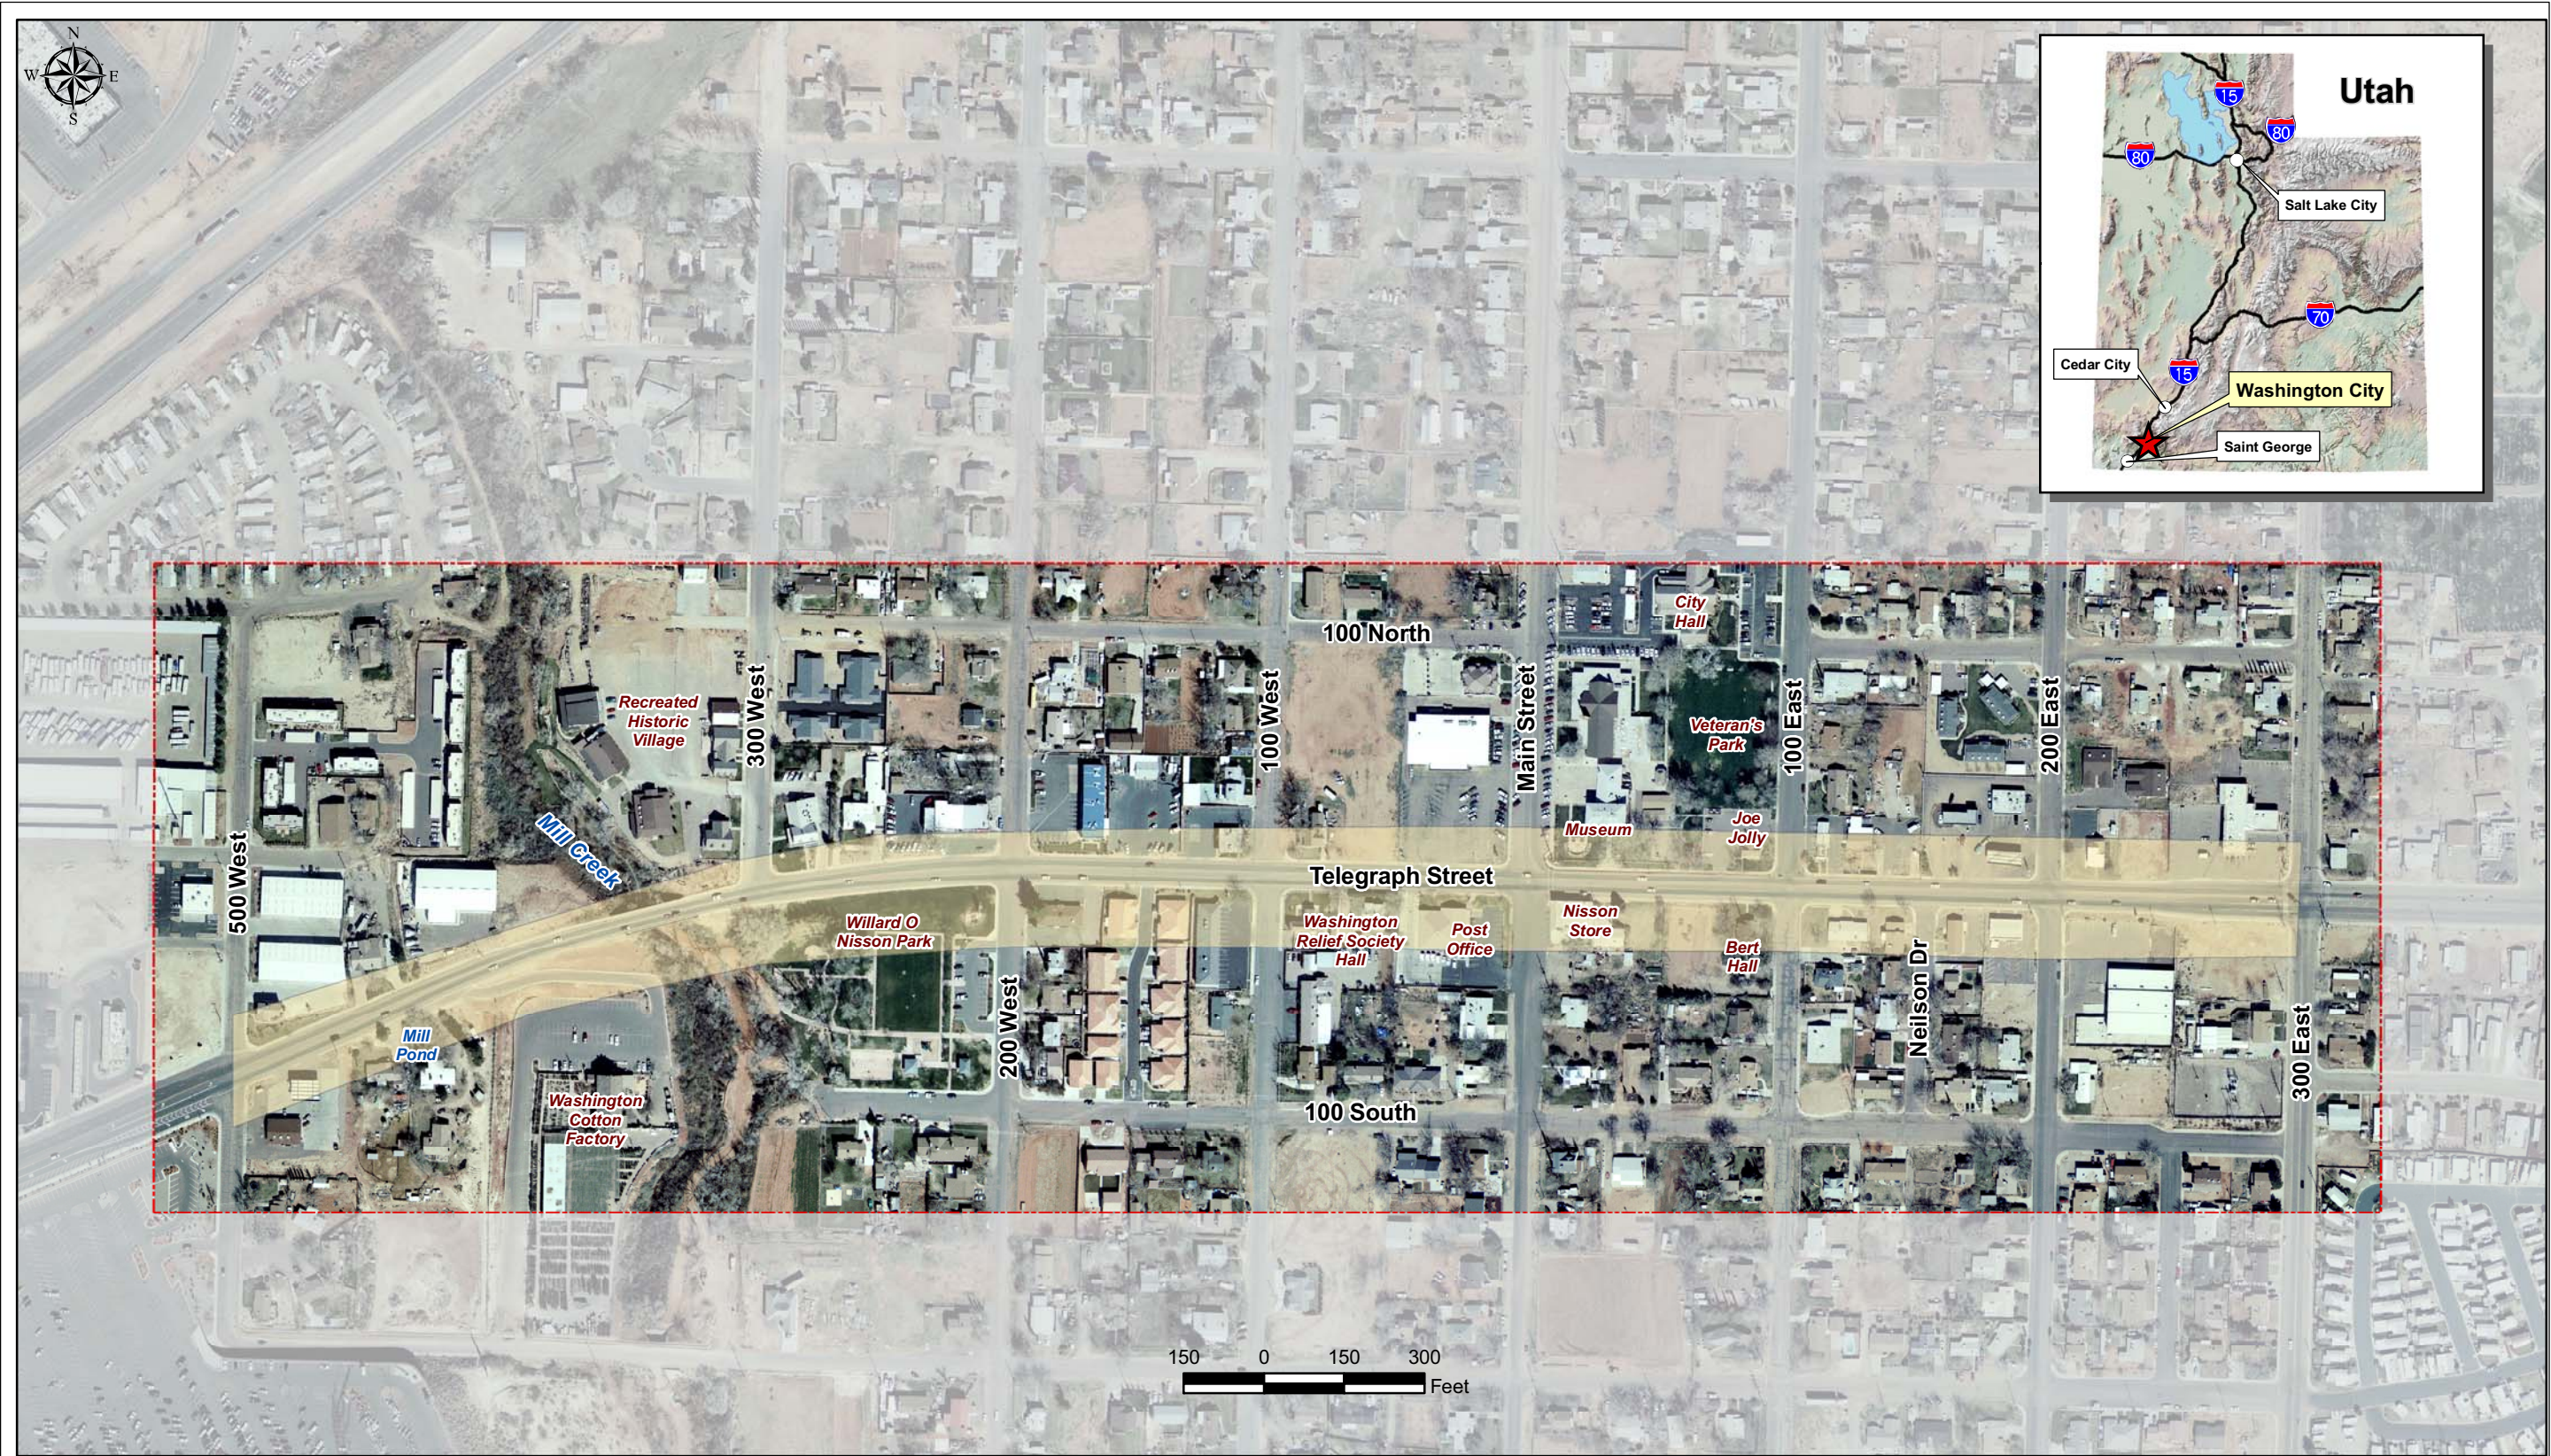
Historic Downtown

Except for a portion from 500 West (MP 0.55) to 300 East (MP 1.29), Telegraph Street is a five-lane roadway consisting of four travel lanes and a median. Between 500 West and 300 East, it is a three-lane roadway, consisting of two travel lanes with a center turn lane and reducing to two lanes on the bridge over Mill Creek. It is this $\frac{3}{4}$ -mile section of roadway that comprises the proposed project area (see **Figure 1.1**).
